Accredited Building Consultants, Inc.

Property Inspection Report

XXX, XXX, FL XXXXX

Date of Inspection: 4/21/2020 Time: 20 inspection man hours

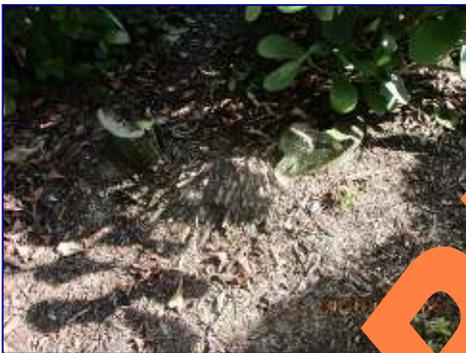
- Tree stumps observed on property. Stumps invite insect such as carpenter ants, termites and other insects which can invade the structure. Recommend removal, consult with arborist.

Stumps - Recommend Removal

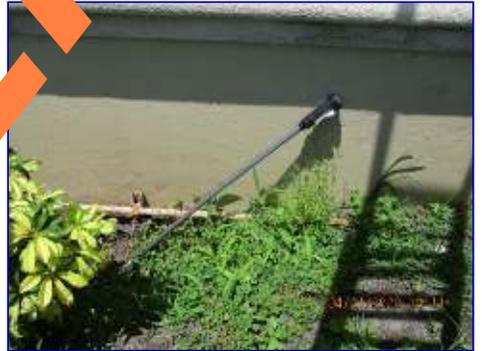
- We recommend all sprinkler heads be evaluated by a licensed irrigation contractor, one or more disconnected or damaged sprinkler heads were observed, see sample conditions photos below.

One or more damaged heads

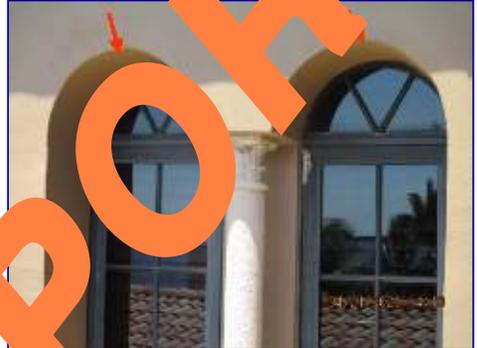
Typical stucco bucket conditions

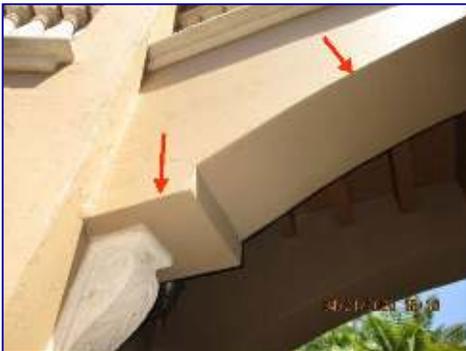
Typical stucco bucket conditions

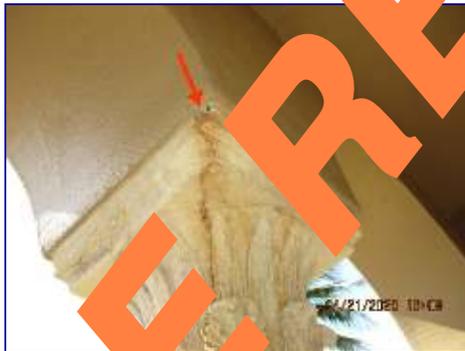
Typical stucco bucket conditions

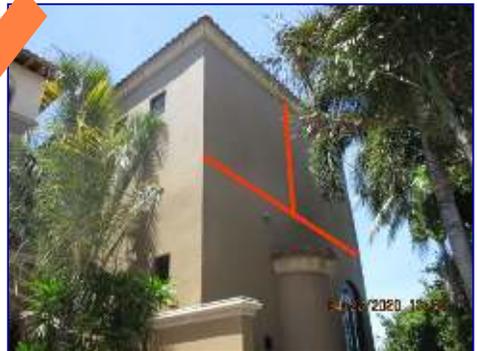
No expansion joints

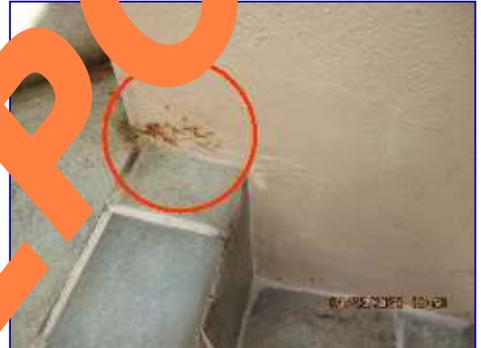
Exposed "rusted" wire lath @

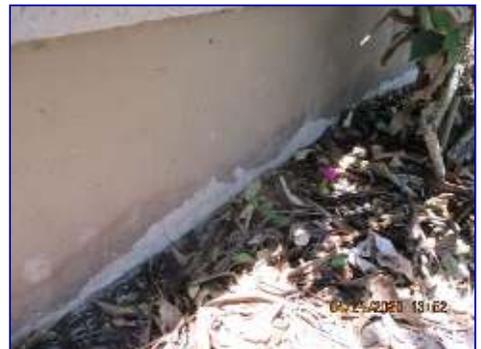
Needs Pressure Wash/Seal/Paint

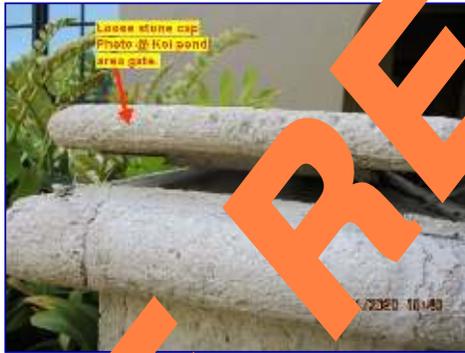
• One or more loose stone caps on short walls at koi pond area, see photo below.

One or more loose stone wall caps

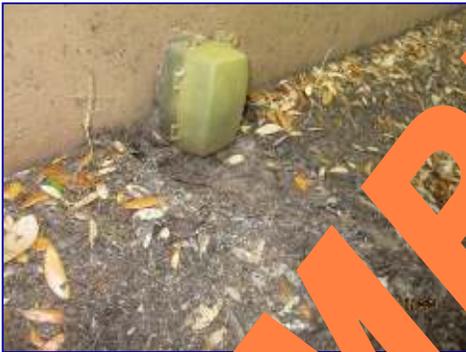
- One or more exterior GFCI receptacle(s) in the structure were found to be defective. Defects can include but not be limited to: too low to ground, broken exterior covers if applicable, loose, cracked, broken, have no power, do not trip when tested, will not re-set when tested, not secure in work box, wrapped in plastic, has wiring/polarity deficiencies, painted over and or does not function as it was intended. Have licensed electrical contractor analyze all exterior GFCI outlets for proper functionality.

One or more: Too low to ground

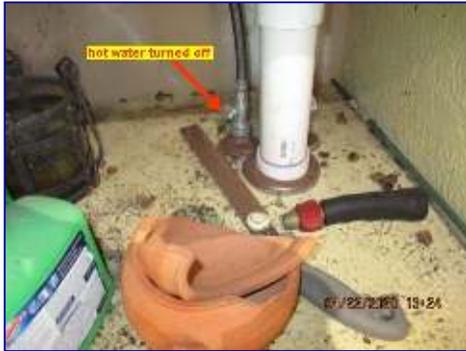
- The hot water for the sink was shut off. Ask current owner why hot water supply shut off.
- The gas grill would not fire using normal controls.
- **IMPORTANT:** The fireplace damper is damaged and non functional. The lever will not open or close the damper correctly or with difficulty. Do not attempt to start a fire until corrected.
- Could not fully inspect the wood burning firebox due to accumulation of ash, recommend regular cleaning.

Hot water shut off valve "Off"

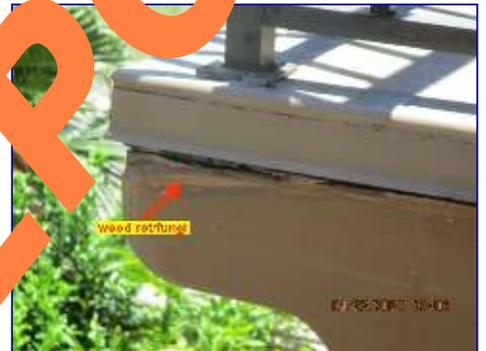
wood rot/fungi-@ balconies

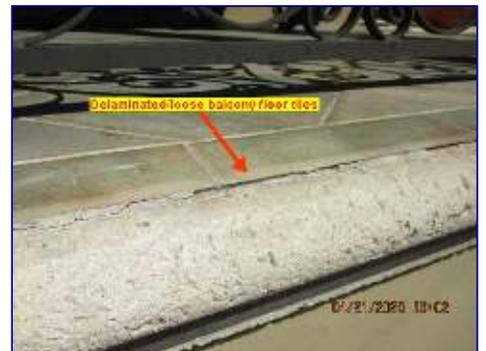
First floor balconies --loose delaminated tiles

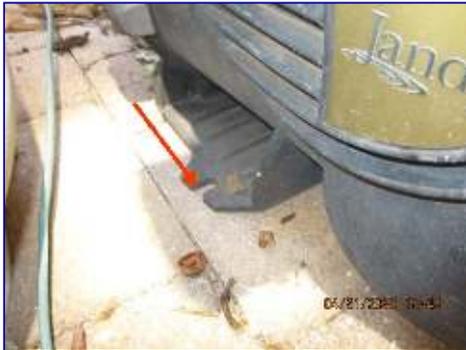
- **RECOMMENDATIONS:** All equipment should be securely fastened to the equipment concrete slab. Equipment installation manuals normally recommend that all equipment be secured to their final resting place. Pool equipment can get blown around during a high wind event such as a hurricane. Equipment may not get blown very far, it may be jarred enough to cause damage. Consult with a swimming pool professional.
- The pump is cavatating, air bubbles found in pool supply lines, reasons could be loss of suction, pump O-Rings poor condition, broken piping, debris in skimmer, loose unions or fittings in plumbing pipes and several other causes. Have swimming pool contractor inspect and repair (see video below of air inside pump).

Not secure

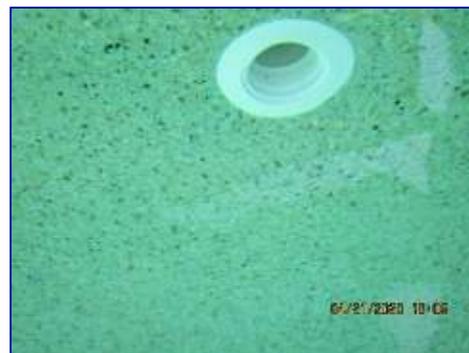
- Missing/damaged or improper return jet fittings observed. Return side fitting should have safety plate or other suction protection over the inlet, consult with a swimming pool contractor for proper application.
- One or more supply jet fittings is missing and or damaged. Have all supply and return fittings inside the pool evaluated by a swimming pool technician, repair/replacements needed.

Return/Supply fitting missing

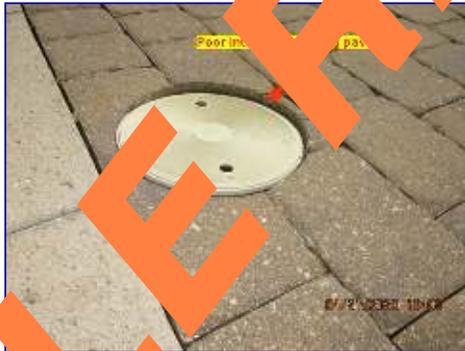
- **POOL RETAINING WALLS & POOLS WITHOUT SCREEN ENCLOSURE:** This portion of report is for pool retaining walls and pools without a screen cage.
- Depressions, low spots and or sunken areas on surface pavers noted. The cause of this condition can be from clogged pipes, inadequate base rock or sand or several other factors. These can become a trip hazard. Recommend that a professional paver install inspect, repair and or monitor for worsening conditions.

One of many areas of settling pavers

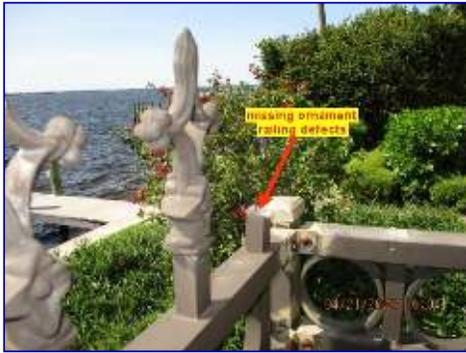
One or more fence/railing defects

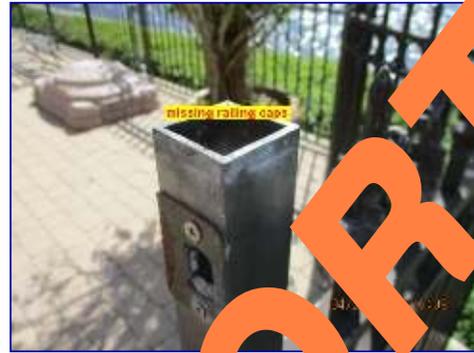
Fence/railing defects

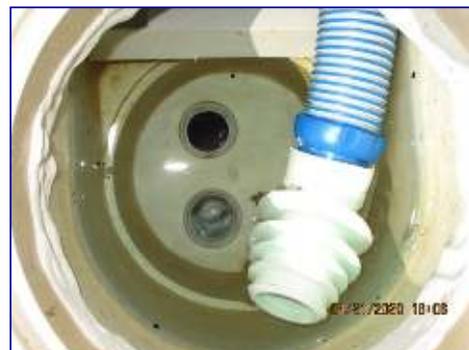
Skimmer basket missing

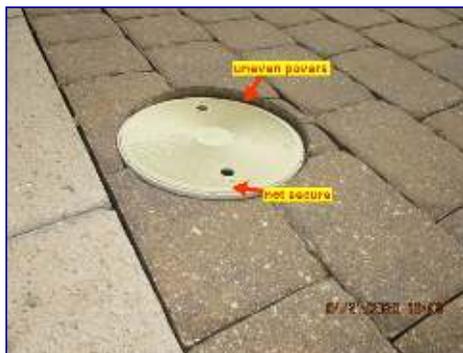
• Maintenance: be sure to flush your equalizer line periodically.
 • The water fill lid is missing the screw or screws to secure the lid. Repair as needed.

Auto fill not secure -uneven pavers

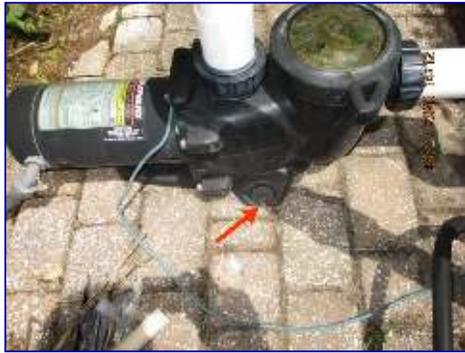
• **RECOMMENDATIONS:** All equipment should be securely fastened to the equipment concrete slab. Equipment installation manuals normally recommend that all equipment be secured to their final resting place. Pool equipment can get blown around during a high wind event such as a hurricane. Equipment may not get blown very far, it may be far enough to cause damage. Consult with a swimming pool professional.

Not secure

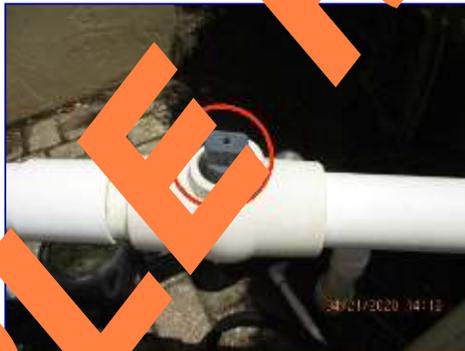
Missing Jandy Valve handle

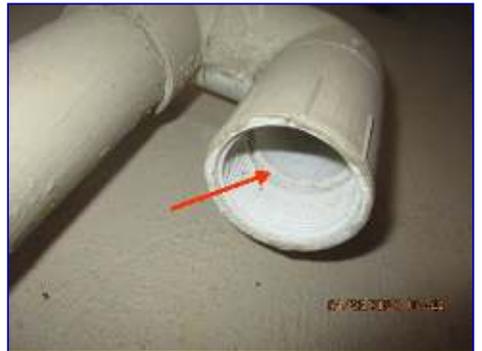
Main drain vent missing screen

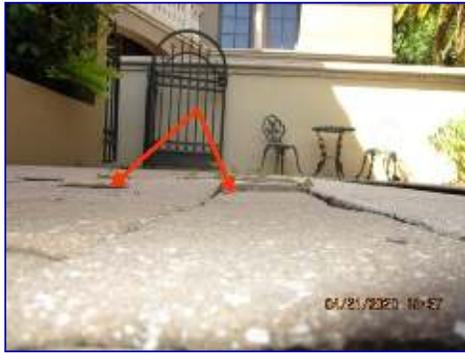
Uneven paver decks

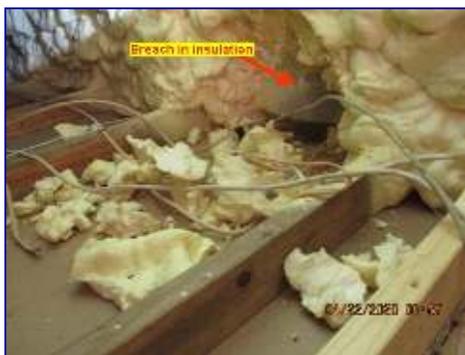
- **Over Office area, Game room/Garage:** Thermal bridging(thermal breaks) occurs when a more conductive material allows an easy pathway for heat flow across a thermal barrier (missing or poor installation of insulation materials). Defects can include but not be limited to: open wall studs, open wall cavities, utility chases, missing insulation, fallen insulation of vertical wall areas, gaps in the attic space or open/closed cell insulation is cut or damaged by wiring installations as shown in the photo below. We recommend having a licensed insulation contractor and/or HVAC contractor familiar with these types of conditions to inspect evaluate and mitigate these thermal bridging areas. For more information please visit this website: <http://www.greenbuildingadvisor.com/blogs/dept/guest-blogs/what-thermal-bridging#ixzz4o3G3OKxy>

Damaged open cell insulation

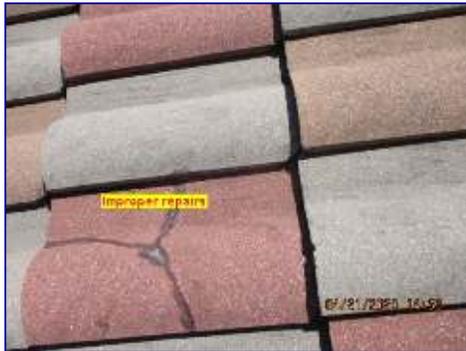
Typical Cracked/Broken Roof Tiles

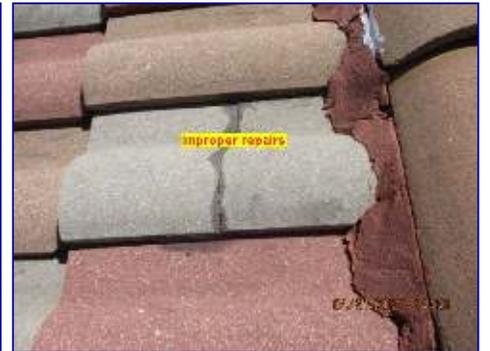
Typical Cracked/Broken Roof Tiles

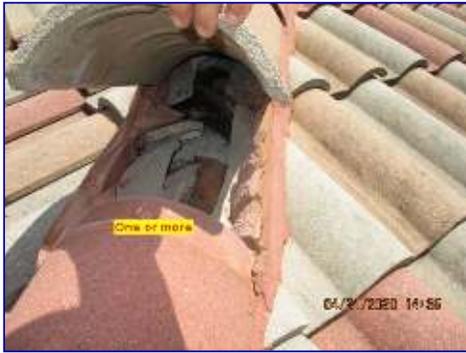
Typical Loose Hip & Ridge Tiles

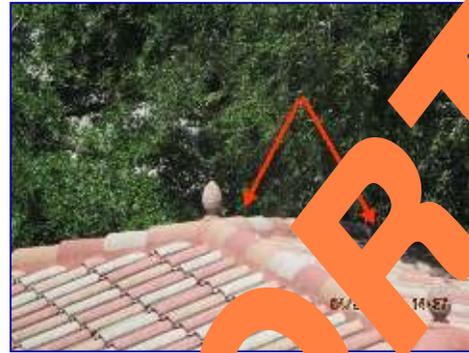
- Tree and or shrubbery branches overhanging roof and/or against siding of structure. Trim trees and or shrubbery that are in contact or proximity to home, as branches can abrade/scrub/sand damage roofing/structure.

Scrubbing tree

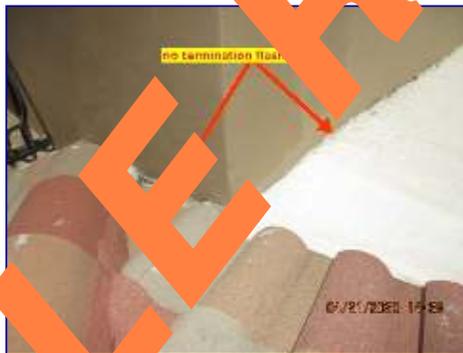
- Standard L flashing observed at the intersection of vertical wall and roof surfaces with no stucco stop or counter flashing. In this case the inspector cannot visually inspect these areas of flashing due to materials coverings up the flashing. These conditions should be monitored on an annual bases. More Info: <http://www.nachi.org/flashing-part2-13.htm>
- Siding and or stucco is in direct contact with roof coverings, there is no clearance of siding to roof coverings. This prevents the inspector visual ability to properly inspect and also will help in the way of the siding materials. More info: <http://www.nachi.org/flashing-part2-13.htm>

No stucco termination flashing

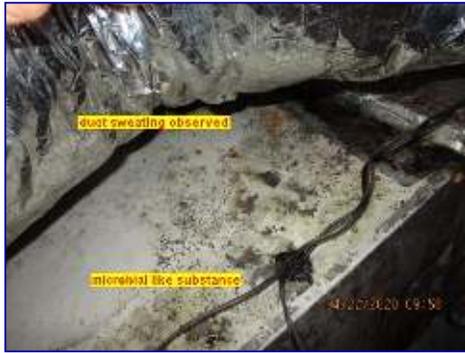
• Issue # 3: Some duct sweating observed on the top of the air handler above the kitchen, see photo below. See "Attic" portion of this report for more information and possible causes. Condensation was observed on top of the air handler indicating a significant amount of duct sweating. There was also some microbial like substance observed growing on the air handler and between the air handler cabinet and the ductwork. Recommend that the ductwork be suspended above the air handler cabinet. Have licensed HVAC contractor evaluate and repair as needed.

A/C # 3: duct sweating -mildew on air handle

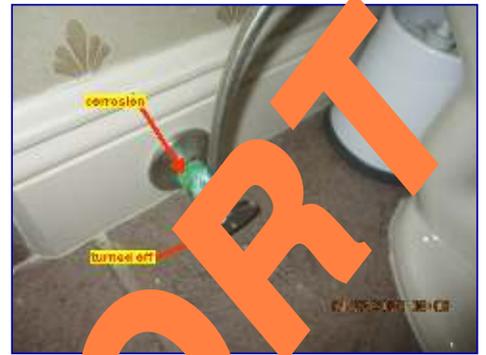
Bath # 7: Corroded stop valve

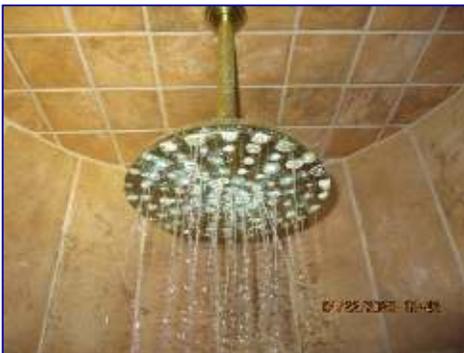
- Bathroom # 1 & 4: Shower heads and body spray heads need cleaning. Device(s) do not spray evenly as they were designed to do so. Naturally, water has calcium and other mineral deposits which over time can (and will) clog shower heads. Try cleaning with vinegar before replacing. For more information visit this website: <http://www.kihow.com/Clean-the-Showerhead-with-Vinegar>
- Bath # 4: Shower head hose is defective. See photo below.

Bath # 1: clogged showerheads

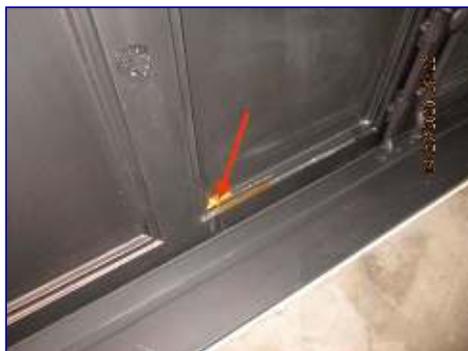
• Loggia South door was observed to have water leaking through door and the door is rusted. Have licensed professional evaluate and repairs needed, see photo below. Cause is unknown.

Loggia South door rusted

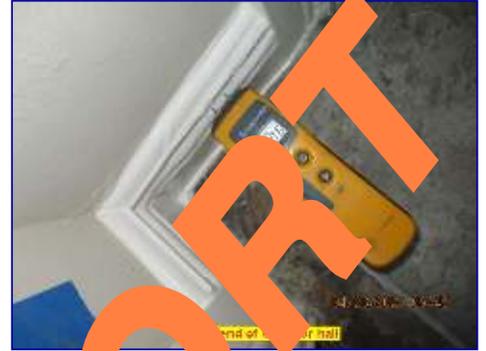
GE SurveyorMaster™- Moisture meter reading above 20% MC

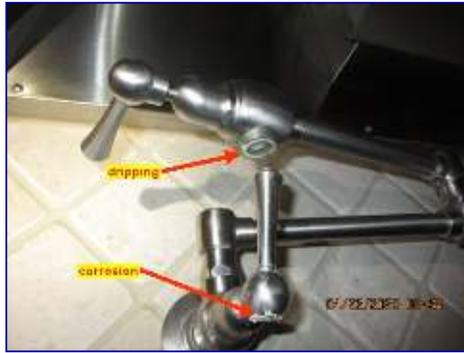
Pot filler--dripping & corrosion
