Accredited Building Consultants, Inc.

Property Inspection Report

XXX, XXX, FL XXXXX

Date of Inspection: 4/21/2020 Time: 20 inspection man hours

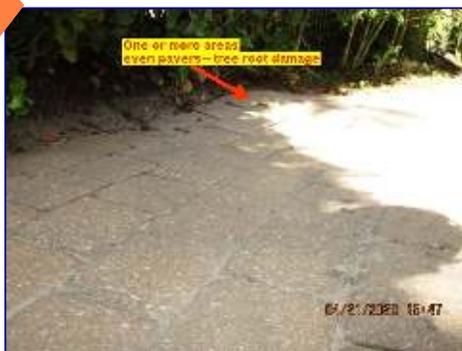
- **ORGANIC GROWTH:** Pavers observed to have organic plants from growing through joints in the pavers and keep clean of live growth to prolonged life and aesthetics.
- **Depressions, low spots and/or sunken areas of surface pavers noted.** The cause of this condition can be from broken pipes, inadequate base rock or sand or several other factors. These can become a trip hazard. Recommend that a professional paver installer inspect and repair and or monitor for worsening condition.
- **Large trees and other types of root systems can damage the look and feel of driveways and walkway surfaces.** Root systems can easily displace, crack and damage surfaces. These are/can become a trip hazard. Recommend having a landscape professional and or concrete/paving contractor evaluate condition (see photos).

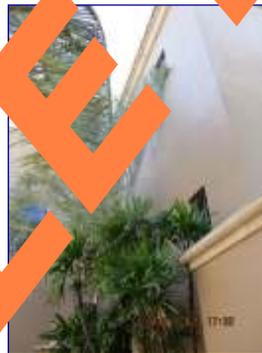
Too Close/Scrubbing/ Rubbing Vegetation

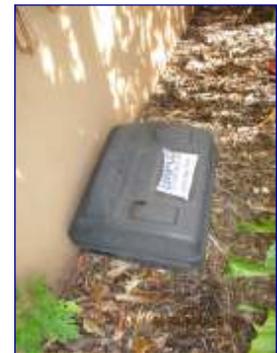
vermin control

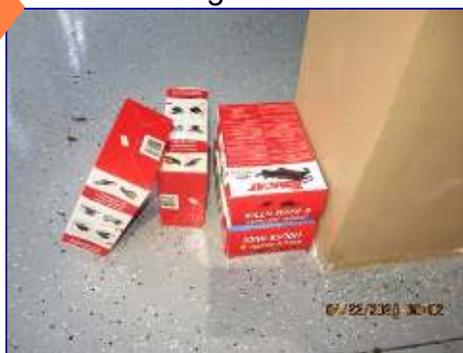
vermin control

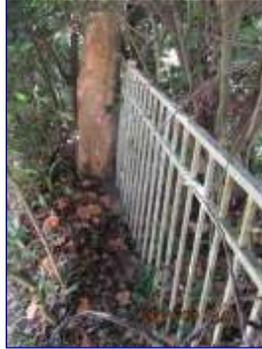
- Fence has trees and or shrubbery limiting the inspection of the fences/gates and or retaining wall(s). Trees and shrubbery can damage fence components and should be cut away and discouraged to grow near the fence. Evaluate conditions after removal.

Vegetation in Fence --Not Inspected

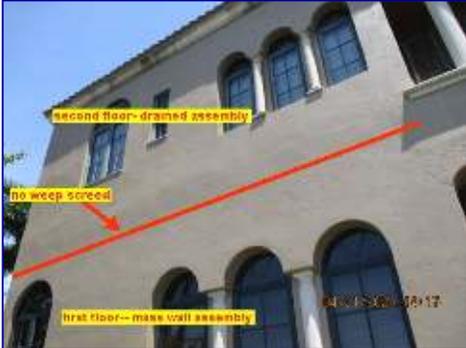
No weep screed at assembly transitions

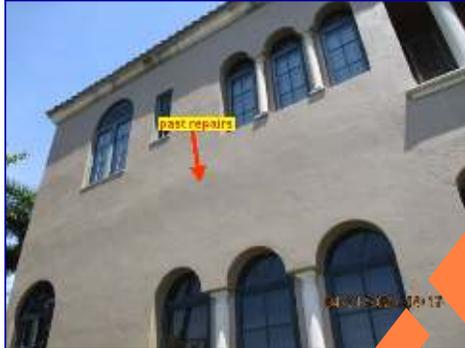
Past repairs observed

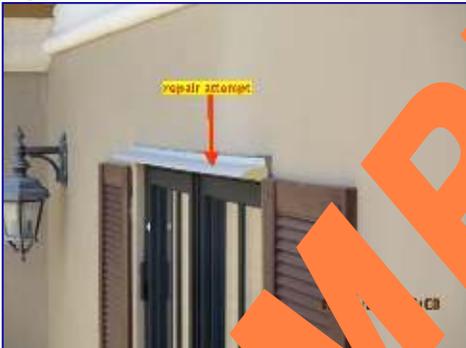
Typical stucco bucket conditions

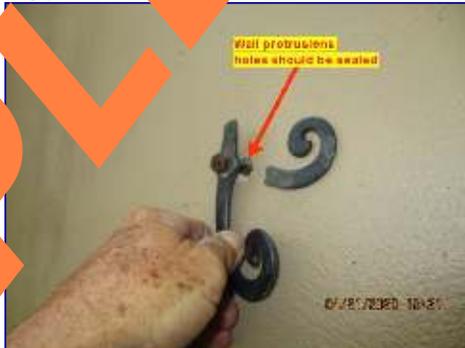
Typical conditions-- all protrusions

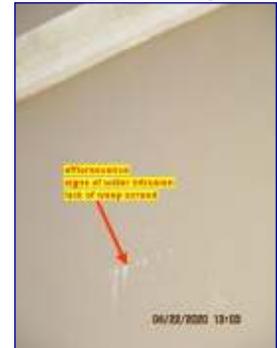
Mid wall efflorescence

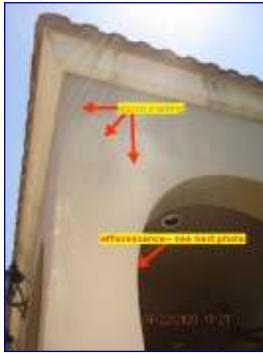
Stucco cracking

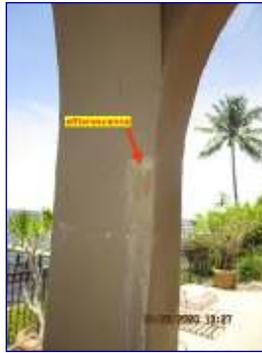
Cracking results in efflorescence

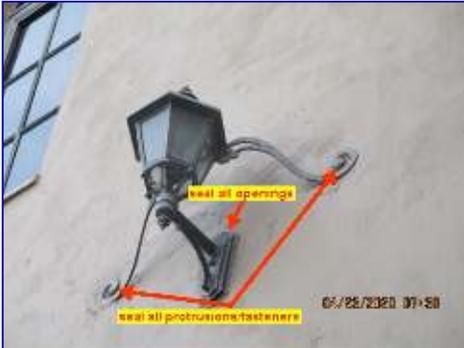
Seal all wall fixtures and fasteners

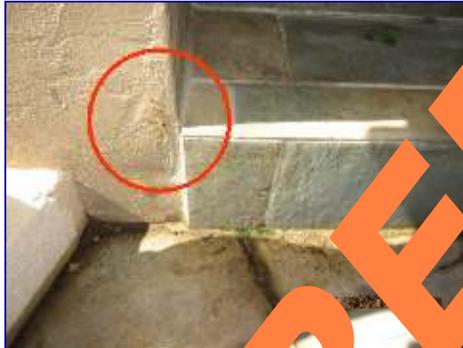
- One or more areas of exposed stucco metal wire lath was observed at the second floor balcony breezeway stair stairway, see photos below. This could be an indication that the stucco was not applied at 7/8" thick as recommended in ASTM and building code standards.

Exposed "rusted" wire lath @ Breeze

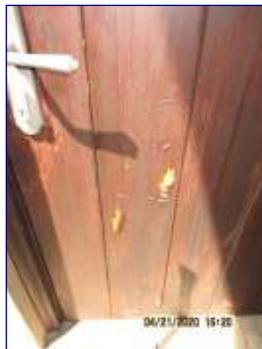
Doors need painting/staining

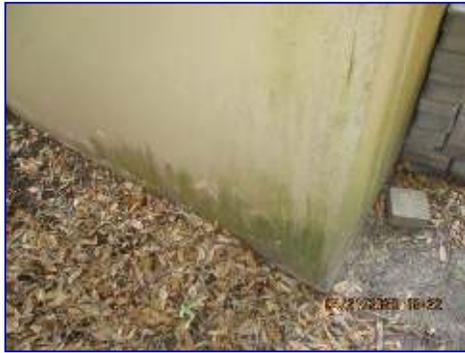
• One or more areas of the structures exterior paintable surfaces are; cracked, blistered, peeling, chalking and or have fungi/mildew growing on the walls. See photo(s) below for locations and conditions. Have licensed professional evaluate and repair/replace as needed.

Needs Pressure Wash/Seal/Paint

NOTE: Affected areas should be pressure washed, sealed and painted. Typical paint coats last about 5 to 7 years under the local climate. On concrete structures coats of paint are the only water proofing membrane to protect the structure from water intrusion. Recommend asking current owner when the last time the structures exterior surfaces were painted. Consult a professional painting/water proofing contractor for repairs. For more information on how to select the proper paint for your building visit your local paint store. Sherwin-Williams Stores are best to get the proper information on what products should be used, website: <https://www.sherwin-williams.com/homeowners/how-to/painting/exterior-painting-how-tos/exterior-painting/sw-article-dir-extchoosepaint>

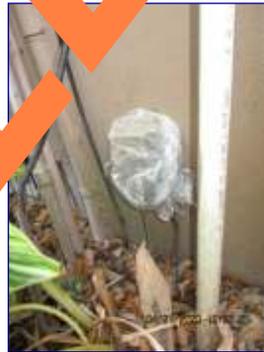
Wrapped with plastic -?

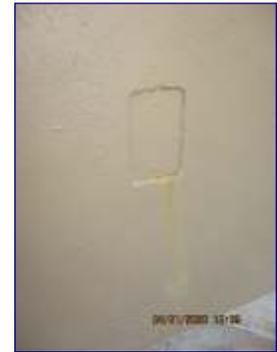
One or more: Removed/missing

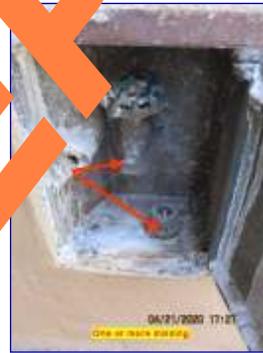
- One or more hose faucets have broken and or are missing vacuum breaker devices. Hose faucets that are connected to a main water supply or other drinking water supply should be equipped with hose connection vacuum breakers (HVB's) to prevent backflow of water from the hose to the water supply. The home may or may not have been required to have these devices, however it is recommended that they be installed to protect your potable water supply. Inspect all exterior faucets and install one onto each exterior faucet. They are easily installed and available at most hardware stores. For more information, visit the website <http://ufdc.ufl.edu/IR00001505/00001>

Typical Missing Vacuum Breaker

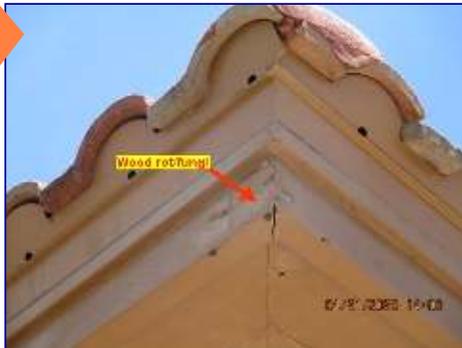
- Disclosure: Due to the height of the structure all wood fascia and soffits could not be probed for wood rot fungi. Wood rot/fungi observed visually from the ground and or with binoculars.
- Wood
- One corner of the wood fascia was observed to have wood rot/fungi, moisture damage. Typically, the areas of concern on wood fascia will be at the corners and any mitered or butt joints. A complete analysis by a professional contractor should be performed and repairs made as necessary.

Wood Rot/ Fungi Observations

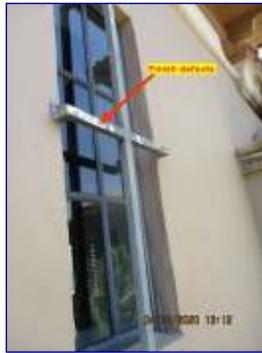
Finish defects

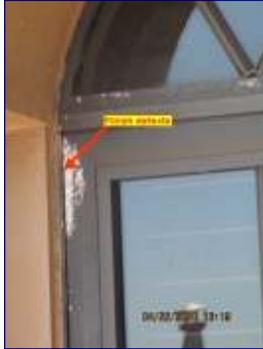
Finish defects

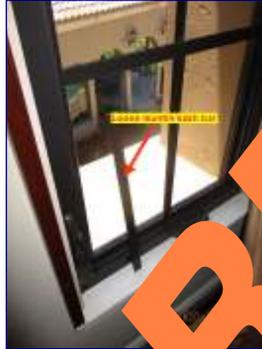
One or more loose muntin

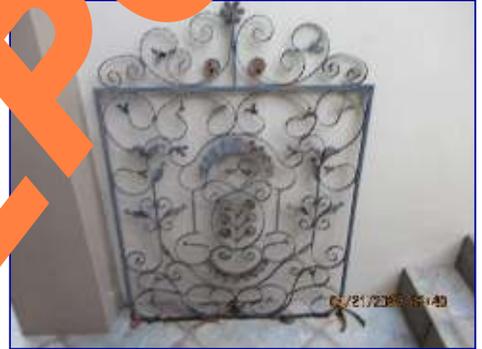
Unknown use for decorative grate

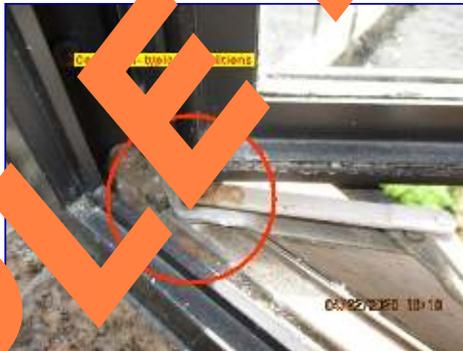
One or more: Corroded operator arms

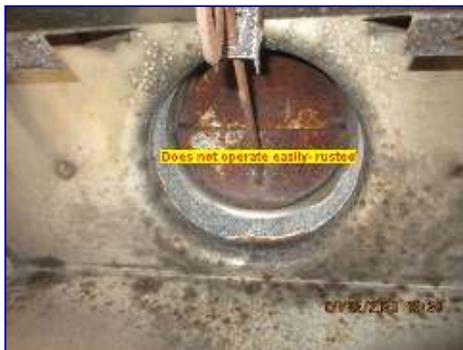
Rusted damper

- The hot water for the sink was shut off. Ask current owner why hot water supply shut off.
- The gas grill would not fire using normal controls.
- **IMPORTANT:** The fireplace damper is damaged and non functional. The lever will not open or close the damper correctly or with difficulty. Do not attempt to start a fire until corrected.
- Could not fully inspect the wood burning firebox due to accumulation of ash, recommend regular cleaning.

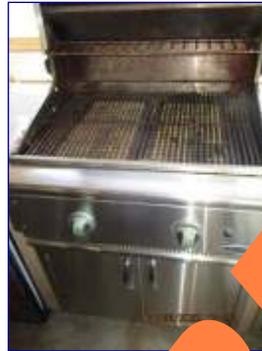
Gas grill would not fire

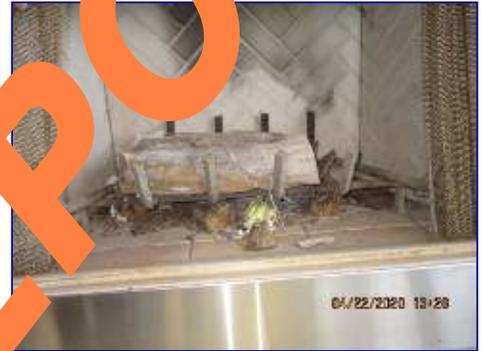
Clean fire place

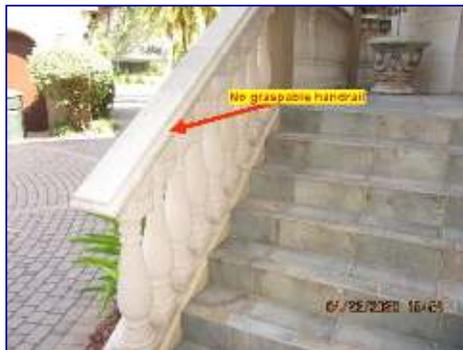
- The fountain area and courtyard area has no railing. Railings are required with drop-offs on accessible decks more than 30" above grade. Flat walking surfaces observed over 30" off the ground without proper protection. The question of the surface is: "Is this an accessible walking surface?" A child could easily access this area!
- Handrails with circular cross section shall have an outside diameter of at least 1 1/2 inches (38 mm) and not greater than 2 inches (51 mm) or shall provide equivalent graspability, see illustration below. If the handrail is not circular, it shall have a perimeter dimension of at least 4 inches (102 mm) and not greater than 6.25 inches (160 mm) with a maximum cross-section dimension of 2.25 inches (57 mm). Edges shall have a minimum radius of 0.125 inches (3.175 mm). Handrail is deficient. See photos below for locations and conditions.

No graspable handrail

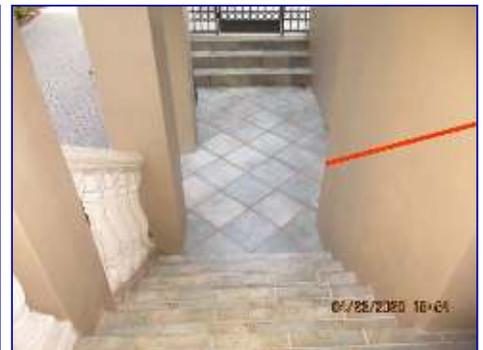
No graspable handrail

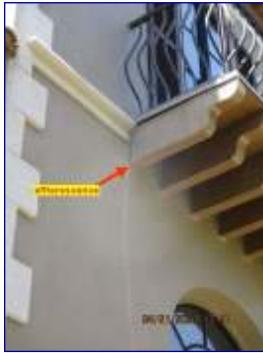
One or more areas of balcony efflorescence

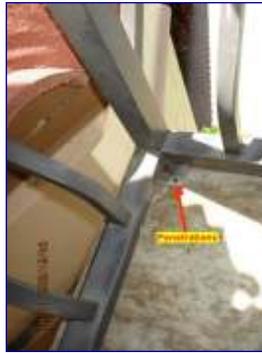
- **Observe that the balcony railing(s) appear to be fastened right through the tile/pavers and into the membrane which can be problematic and is not normally recommended. Recommend securing a set of building plans to preserve installation details and or industry approved methodology used in the construction of the open balcony decks and/or railing details. All railing supports also be assessed for proper securing to columns, and to wall/stucco surfaces, see photo of loose fastener(s). For more information about these types of decks and a better understanding please visit this website: http://www.duradek.com/_customelements/uploadedResources/WhitePaperTiledek.pdf**

Penetrations through balcony membrane

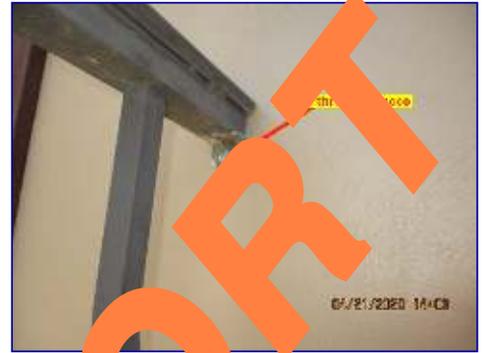
Penetration through stucco walls

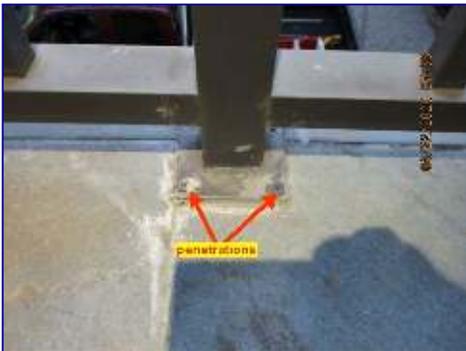
Penetrations through balcony membrane

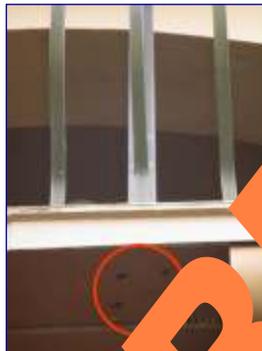
Penetrations through balcony membrane

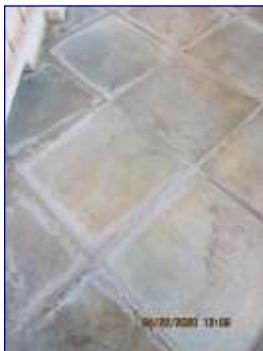
Efflorescence through tile

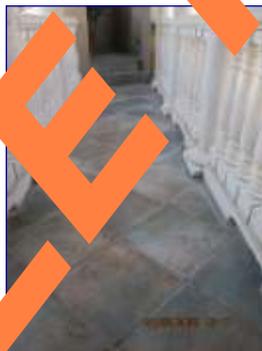
Efflorescence through tile deck

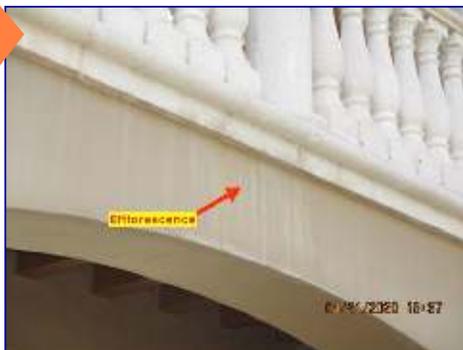
One or more areas of balcony efflorescence

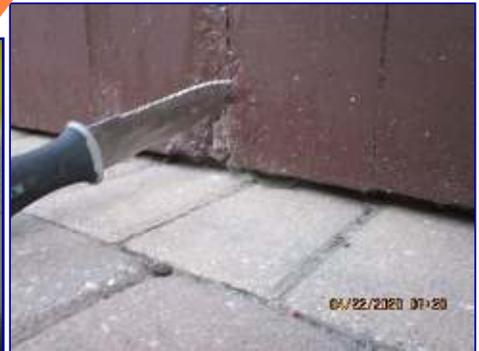
- One or more doors are noisy and squeaks when moved. We recommend lubrication on the rollers and tracks.
- Rusted, bent, dented, wood decay, weathered and damaged door panel(s). Recommend full review and or repair or replacement by a certified overhead garage door contractor.

Lube you overhead door twice a year - Where to Illustration Overhead garage door safety wood rot/ fungi @ garage doors

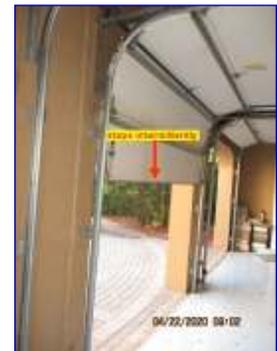
- The opener light cover is; missing, broken, cracked and or damaged and should be repaired/replaced.
- The light to the garage door opener did not illuminate. Check bulb first as first means of cure.

Door opener defects

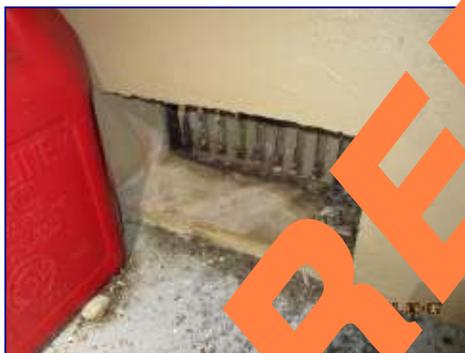
- Flood ports should be cleaned and lubricated for proper operation. Monitor flood ports for incidental water intrusion, water staining, etc.

Flood ports -clean, monitor

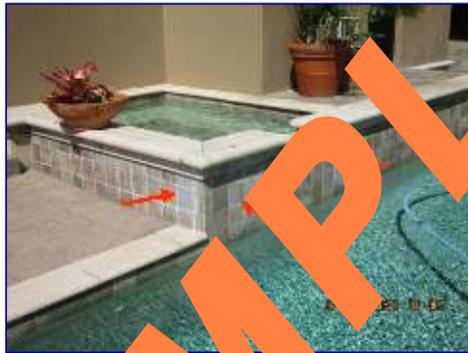
• Efflorescence observed around the front face of the spa. This is a common occurrence with raised spas. A diligent cleaning and maintenance program will alleviate this issue.

Efflorescence on spa

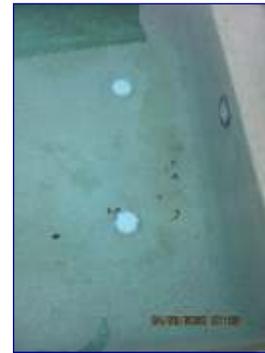
• : Minor stains observed on pool finish. Pool staining or swimming pool staining, usually refer to areas of discoloration on swimming pool walls, floors, steps, or any surface of the swimming pool in contact with pool water. There are two main causes of swimming pool stains; dissolved metals and algae growth. Have pool professional evaluate and clean as needed. For more information: <http://www.poolforthought.com/glossary-term/pool-stains/>

Interior surface stains observed.

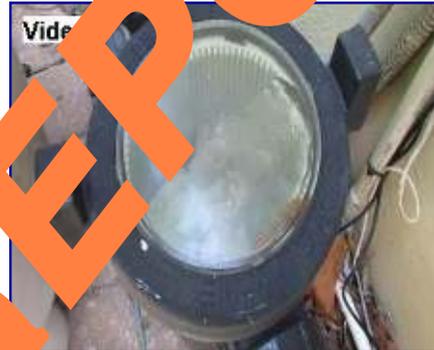
Pump Cavitation

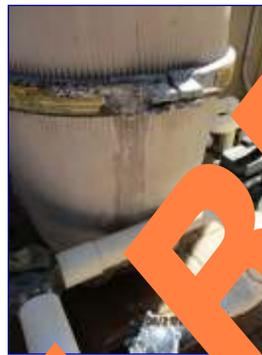
- : Filter is leaking in one or more places, see photo below. Have filter fully evaluated by pool professional.

Filter leaking

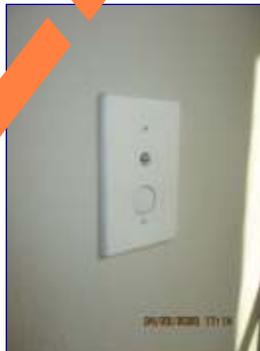
- See "Stairs/Handrails" portion of the report for more information.
- Door and window alarms have been removed or disconnected by the current owner. Ask owner if they still have the alarms or reconnect and prove that they are functional. If you have small children or grandchildren be sure to install a door or reinstate the alarms. If not at least you will know that the alarms are properly functional for the next person(s) you sell the home to. You may be responsible for the door alarms when you go to sell the home. NOTE: This disclosure goes for both pools and all doors windows that access these pools.

Alarms disconnected

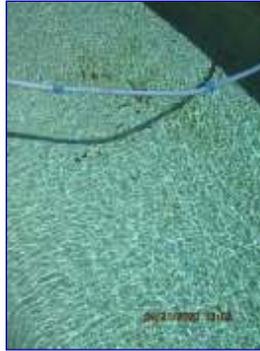
- Water is not tested for chemistry and or temperature during this inspection. Visually the water chemistry appears to be normal.
- Water is clear.
- Organic debris in bottom of pool, needs cleaning.

Debris/leaves in pool

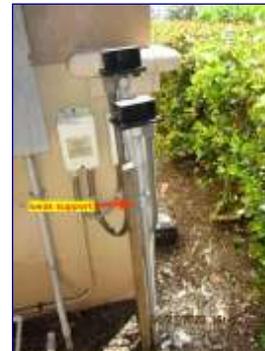
- Light(s) appears in satisfactory and functional condition with normal wear for the age, no major system safety concerns noted at time of inspection.
- The 2X4 post for the pool light junction box is deteriorated and just needs to be replaced, see photo below.

Weak light junction box support

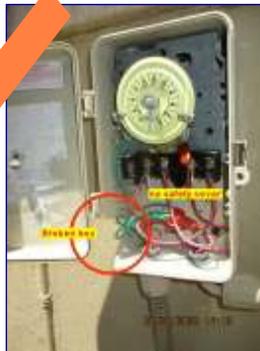
- Damaged and missing protective cover inside timer, needs repair, replacing to avoid potential electrical shock.
- Door or surround damaged; cracked/not weather proof missing, rusted, damaged, broken hinge, latch or won't stay closed. The door must remain latched to keep weather out of electrical connections. Repair and or replace.

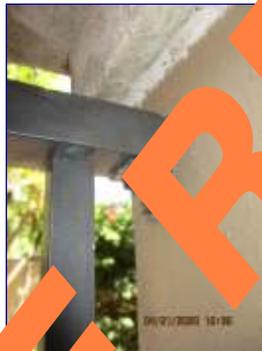
- See "Child Safety Barriers" portion of this report for more information.
- Pool fence/gates are damaged loose and should be evaluated by an aluminum contractor, see photo below for loose railing brackets.

Loose handrail connections

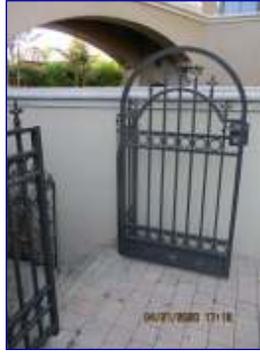
The gate does not self close!

No self-closing gate

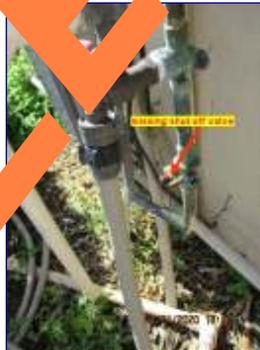
- Maintenance: be sure to flush your equalizer line periodically.
- The shut off valve for the water fill unit is rusted and or there is no valve handle, the photo below

Shut off valve missing/rusted

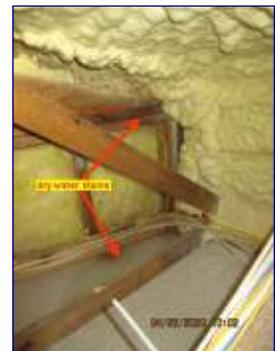
- Engineered roof trusses with plywood/OSB substrates.
- LIMITED ATTIC ACCESS: As stated in the “Access” portion of this report and the “Attic Introduction” some areas of the attic could not be accessed. We cannot comment on any defects, if any that are not visible due to these conditions.
- DISCLOSURE: There is water stains in the attic over the laundry/utility room (see photo below) . The owner disclosed in the owner's disclosure that there was a leak at this area and that it has been repaired. Please closely monitor conditions.

Water stains --over pantry area

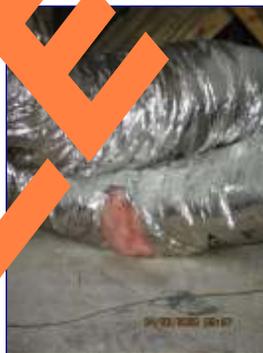
- Flexible duct work with ridged fiberglass mixing boxes and plenums.
- **One or more vapor barrier of flexible insulated duct work (Jacket) is torn/damaged. Repair torn or damaged vapor barrier/jacket with duct tapes listed and labeled to UL 181B. If the insulation is penetrated, replace flexible duct or treat as a splice. Recommend evaluation by a certified HVAC technician. The defect shows up over the kitchen area. More info: <https://dengarden.com/home-improvement/How-to-Repair-Torn-or-Damaged-Air-Conditioning-Duct#:~:targetText=Close%20the%20outer%20liner's%20rip,the%20mesh%20with%20duct%20mastic.>**

N/C # Torn ductwork over pantry/kitchen area

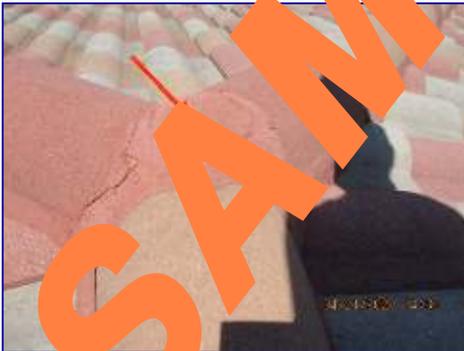
Missing tile/cap -one or more

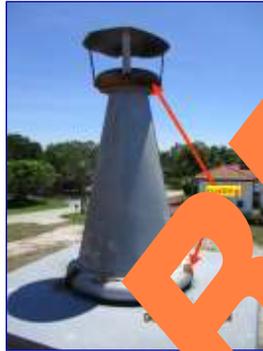
- For more information about chimneys visit this website: http://inspectapedia.com/chimneys/Chimney_Inspection_Report.htm
- See "Attic" portion of this report for more possible information about the chimney.
- Metal Furnace chimney cap is; missing, wrong type, rusted and is damaged in such a way that the device cannot perform as it was intended. Defects like this can allow water entry and can cause leak dripping. Have licensed professional repair as needed, see photos for more info. http://inspectapedia.com/chimneys/Chimney_Cap_Tops.jpg

Monitor resting at South metal chimney

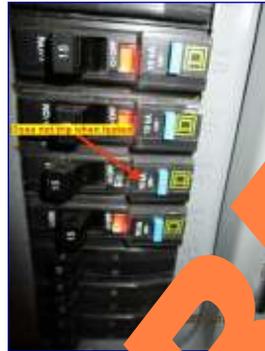
Square D Blue Breaker Recall

Panel B -Breaker panel defective

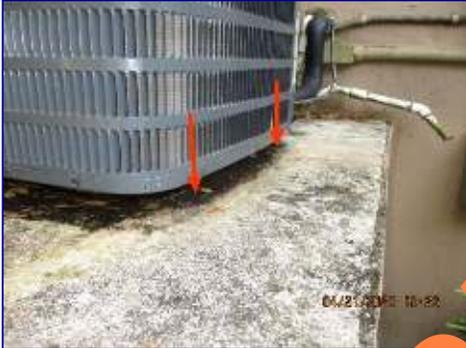
- One or more Damaged, missing appliance tie downs observed. Exterior appliances should be secured to the slab with straps or metal connectors in case of high wind event such as a hurricane. More Info: http://floridabuilding.org/upload/PR_Instl_Docs/FL14239_R3_II_Dwg.pdf

One or more condensers - not tied down

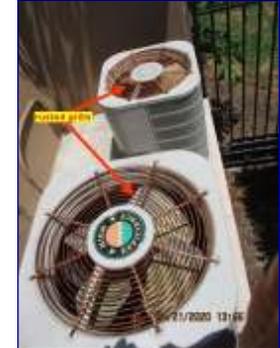
- One or more condensers: Minor rust and or rust stained condenser cabinet, fan motor and or fan cage observed. The cabinet houses the inner workings of the condensing unit and does not affect the operation of the units unless they become severely deteriorated. Arresting the rusting can prolong the cabinets' life, monitor conditions.

One or more condensers - rusting

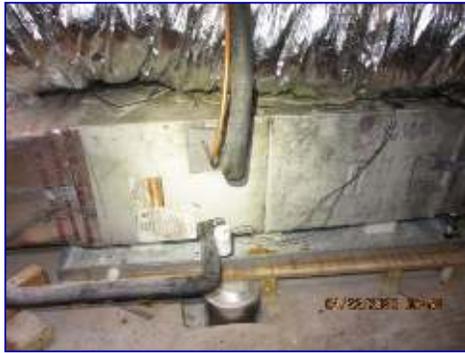
Air Handler Zone # 3

• Zone #3 Air handler cabinet appears to have a mold like substance on it. There are many causes for this to be numerous to mention here including but limited to; high static pressure, Fan speed levels, fan speed, dirty filters, duct positioning/sizing and lack of air handler cabinet insulation or low R-value, etc or breach in open cell insulation. We recommend having the system analyzed by an HVAC contractor that is a specialist in air flow diagnostics and has Mold and Mildew (Indoor Air Quality) experience.

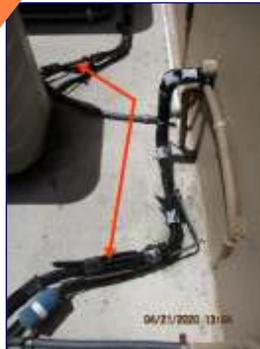
• One or more Units - One or more areas of the foam insulation on suction line(aka, Line set) missing and or damaged. Recommend that all line sets be insulated with damaged and properly sealed insulation to maintain the systems high efficiency. The insulation should be inspected and maintained from the condensing unit all the way to the air handler. Have licensed professional evaluated and repair/replace as needed. More Information: https://www.aiaa.com/aircond/Refrigerant_Piping_Insulation.php

One or more - line set insulation damage

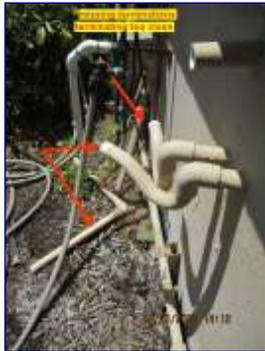
- One or more units: Primary drain line improperly discharged over unapproved site. Condensate shall not discharge into a street, alley or other areas to cause a nuisance, i.e. "do not discharge HVAC condensate over a sidewalk/parking area". Drain lines should also not discharge closer than 12" from an exterior wall/foundation.

One or more - primary drain line details

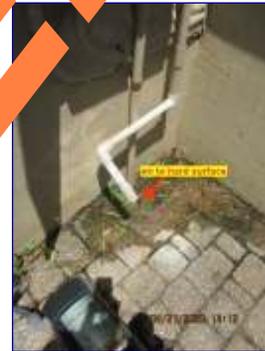
- One or more units: Condensation pipe termination trap has fallen off the primary drain line termination point, simply remove and reinstall the S Trap. See photo(s) below for locations and conditions. Have licensed professional evaluated and repair/replace as needed.

One or more - primary drain termination

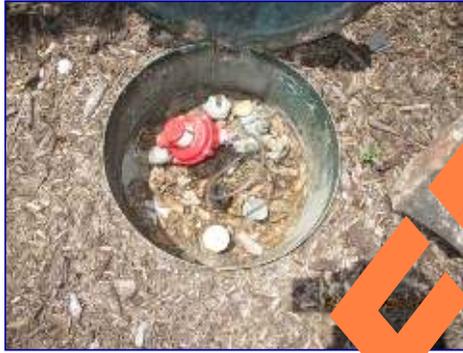
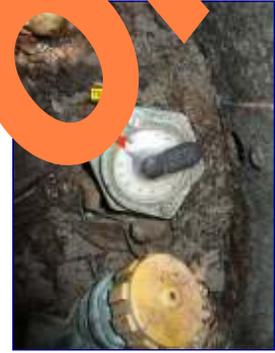
- Appears in satisfactory and functional condition with no visible leaks for the age, no major system safety concerns noted at time of inspection. Tank is 70% full

L/P gas tank with lid removed

70% full of L/P gas

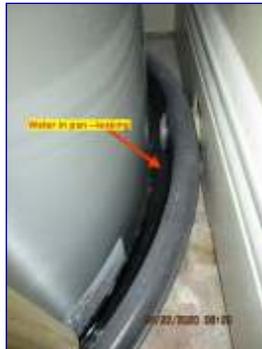
- The hot water in the house is between 110°F and 115°F. HOT WATER WARNING: According to the Consumer Safety Commission., at 120°F it takes five minutes of constant contact to produce a third degree burn. At 130°F, the exposure time is reduced to 30 seconds. At 140°F, the exposure time is reduced to 5 seconds. At 150°F, the exposure time is reduced to 1.5 seconds. Recommended temperature should be set at 118-122 °F. Lowering the temperatures can extend the life of the heater, reduce the risk of burns, and improve energy efficiency and conservation.
- Water observed in the emergency catch pan located under the hot water heater. The cause of this condition could be a rusted leaking tank, leaking inlets or outlets, leaking or faulty TPRV or a number of other items. Have certified plumbing contractor inspect appliance for the cause of this water in the catch pan.

Water in drain pan--leaking !

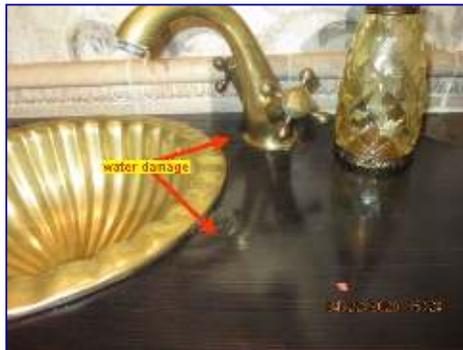
• Bathroom # 3: One or more counter top(s) and/or back splash(s) are damaged, chipped, burned, loose, delamination, swollen, cracked, worn or damaged in some way. If the top has a molded sink and is loose it is imperative that the top be secured to the cabinet base. Consult with a contractor familiar with these products for repair/replace options.

Bath # 3: Water Damaged counter top

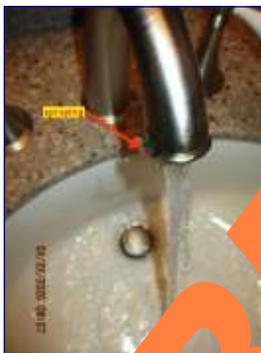
- All Baths: One or more pop up drains will not hold water inside sinks.
- Bath # 7: Aerator is blocked, missing or is not functioning as intended, suggest repairs for proper flow and operation.

Bath # 7: Aerator blocked

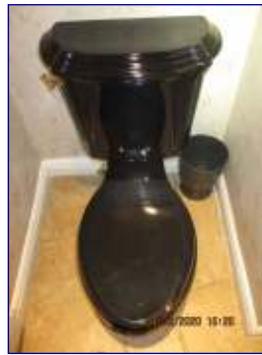
- Bathroom # 2, 3: Water closet is not secure to floor flange. Loose fixtures can result in water damage, damage to supply lines, drainage pipes, and damage to the wax ring. Properly re-sealing and re-securing the fixture is suggested. This type of damage is not always visible or accessible to the inspector at time of inspection. Recommend further evaluation by a licensed plumbing professional.
More info: <https://www.naturalhandyman.com/iip/inftoi/inftoi8.html>

Bath # 2: Toilet loose to floor/not secure

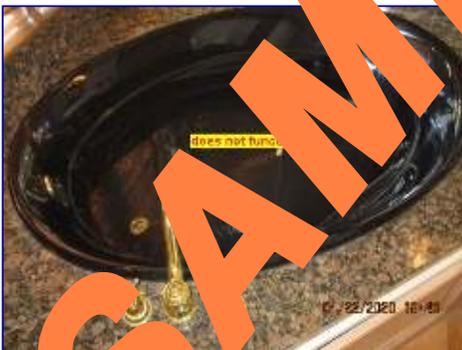
- Master Bathroom # 1: Unable to test Hydrotherapy tub, water and or power turned off. Recommend confirming proper operation prior to close.
- Master Bathroom # 1: Hydrotherapy is inoperable, recommend review by a licensed plumber for repair or replacement, as necessary, prior to close.

Bathroom # 1: Hydro tub does not operate

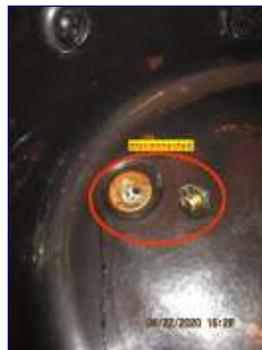
- Bathroom # 1: Hydrotherapy tub waste stopper is either not present or is disconnected from the strainer body.
- Bath # 5: Tub spout is loose to the supply pipe and or needs to be sealed. This defect could be allowing water to leak behind the wall. Recommend contact with a qualified contractor to evaluate and repair.

Bath # 1: Waste defects/observations

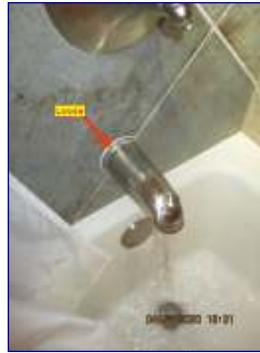
BaTH # 5: Loose tub spout

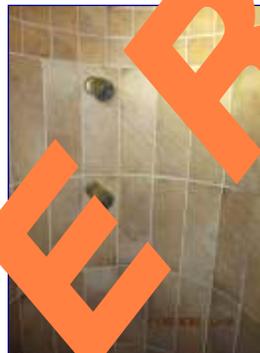
Bath # 1: clogged body spray

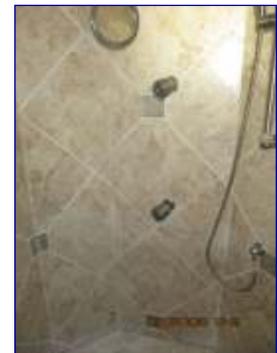
Bath # 4: clogged body spray

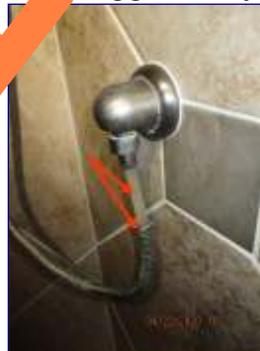
Bath # 4: damaged shower head hose

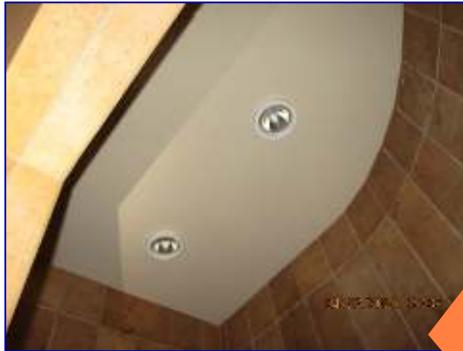
- Bathroom # 1: Tub/Shower light fixture is improper. Light should be recessed vapor proof fixture. Consult electrical contractor for proper repairs.

Bath # 1: no vapor lightbulbs

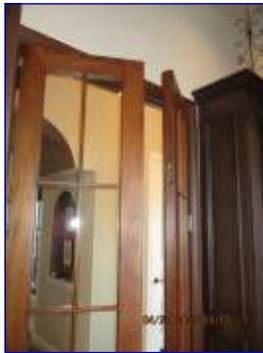
- Study and Master Bedroom #2: One or more doors do not fully open and close as designed, closes on it's own, has loose hinge(s), is hinge bound, rubs the floor, rubs the jamb, T- astragal issues or does not operate as intended, repair/replace as needed.

Do not open and close properly

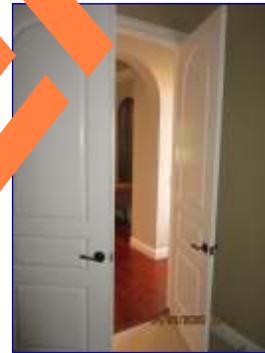
Do not open and close properly

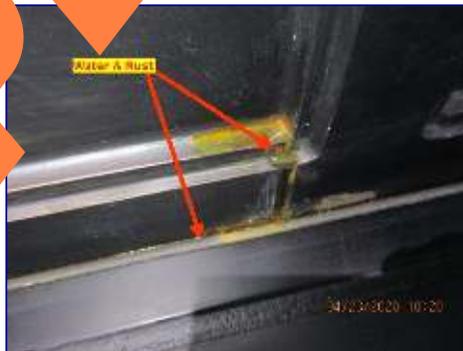
- Master Bedroom #2: Southwest balcony door was observed to have water leaking through door and the door is rusted. Have licensed professional evaluate and repairs needed, see photo below.

Rust and water observed

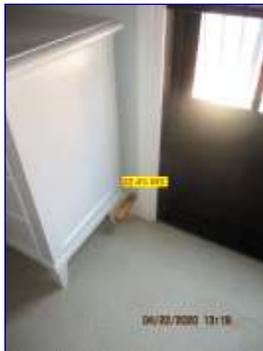
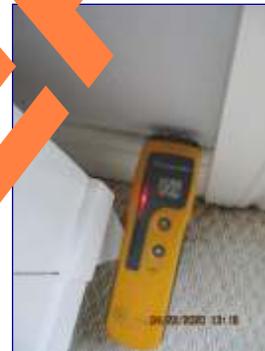
• Guest bedroom # 3: GREATER THAN 20% MOISTURE PRESENT. A moisture content (MC) reading greater than 20% was observed in one of the more areas of the room. Evidence was gathered by use of a GE-Surveymaster –Protomiter™- Moisture meter and/or thermal imaging equipment. Building materials that contain an MC of over 20% are considered wet and have a high probability for microbial growth. Client may entertain exploratory/destructive investigation by a licensed professional proficient in water intrusion and mold remediation protocols. NOTE: Immediate weather conditions and tenancy have an effect on how readings can be interpolated. Inspector will only note this finding if the percentage of MC is significantly higher than the base reading of other like-kind building components. NOTE: See Living room/Dining room portion of this report for related water intrusion. See photos below for locations, readings and findings.

Moisture Reading Location

GE-Surveymaster™- Moisture meter reading above 20% MC

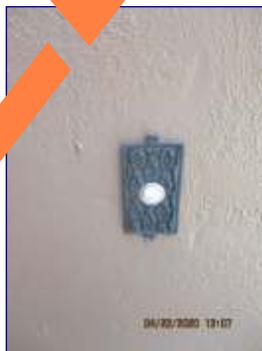
- Main Entry Door Bell not working: Cause could range from faulty bell, wiring, transformer broken or missing button. Have electrician or person's familiar with light electronics inspect and repair.

Main Entry Door Bell -Not Working

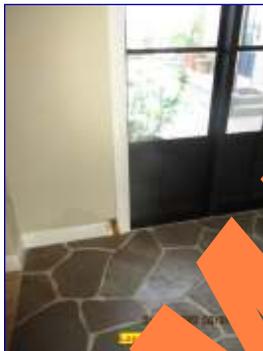
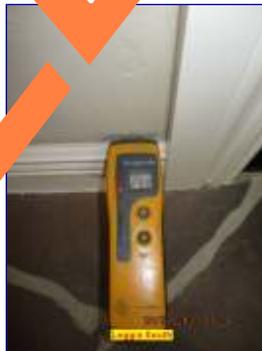
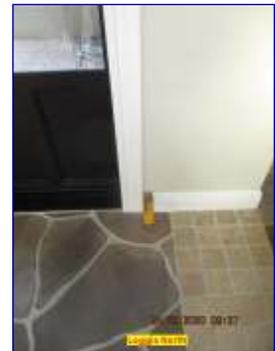
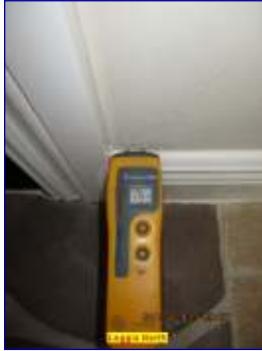
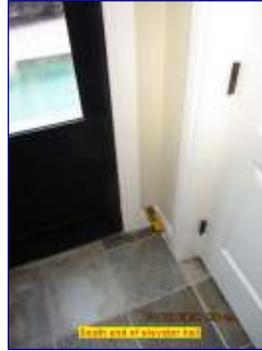
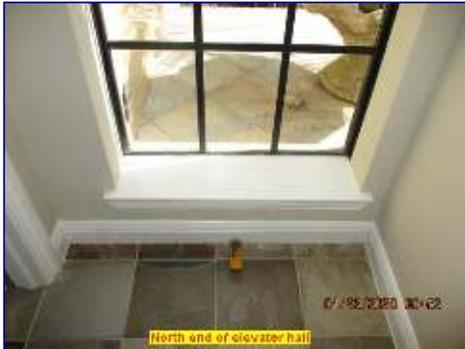
• North side of Loggia: **LESS THAN 20% MOISTURE PRESENT.** A moisture content (MC) reading less than 20% was observed on one or more areas of the room. Evidence was gathered by use of a GE-Surveymaster –Protomiter™- Moisture meter and/or thermal imaging equipment. Unfortunately when readings are below 20% we cannot ascertain if the area has a moisture or an inactive issue. Since the inspection is a snap shot in time we highly recommend that the area be closely monitored at all times until definitive clarification has been accomplished by licensed professionals and/or by the tenant of the property by means of use. NOTE: Immediate weather conditions, humidity levels and tenancy have an effect on how readings can be interpolated. Inspector will only note this finding if the percentage of MC is significantly higher than the base reading of other like kind building components. See photos below for locations, readings and findings.

• South side of Loggia and North & South side of first floor elevator hallway: **GREATER THAN 20% MOISTURE PRESENT.** A moisture content (MC) reading greater than 20% was observed in one or more areas of the room. Evidence was gathered by use of a GE-Surveymaster –Protomiter™- Moisture meter and/or thermal imaging equipment. Building materials that contain an MC of over 20% are considered wet and have a high probability for microbial growth. Client may want exploratory/destructive investigation by a licensed professional proficient in water intrusion and mold remediation protocol. NOTE: Immediate weather conditions and tenancy have an effect on how readings can be interpolated. Inspector will only note this finding if the percentage of MC is significantly higher than the base reading of other like kind building components. Over years of use, water intrusion into the building materials can become damaged/ swollen and unsightly with a chance of microbial growth. See photos below for locations, readings and findings. NOTE: The South side of the Loggia may be connected with the wall/balcony leak at Guest bedroom # 3 on the 2nd floor.

GE-Surveymaster™- Moisture meter reading above 20% MC

Moisture meter reading below 20% MC

GE SurveyorMaster™- Moisture meter reading above 20% MC

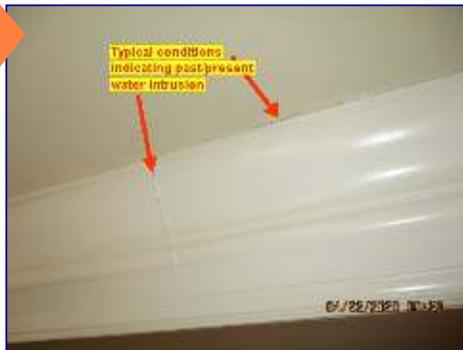
Living Room ceiling

- **DISCLOSURE:** Living Room: Do to the suspensions of the balconies being problematic there are areas (marked with blue tape) of drywall ceilings and crown molding that are indicative of past/present water intrusion. Client should carefully monitor this area. Note that there were no abnormal moisture meter readings in this area at the time of the inspection.
- All other areas of the ceilings appear in satisfactory and functional condition with normal wear consistent with its age. No major system safety concerns noted at time of inspection. Minor stains, blemishes, cracks, small holes and nicks that may be observed can easily be repaired with spackling and or joint compound and painted to match.

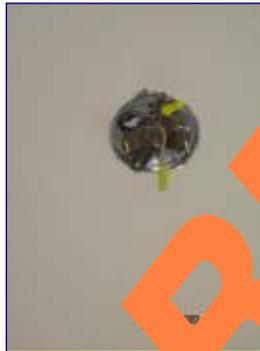
• Formal Living Room Missing, Worn, Loose, Cracked or damaged receptacle cover plates observed, recommend, inspect, repair and or replace for safety purposes.

Living Room: Ceiling outlet

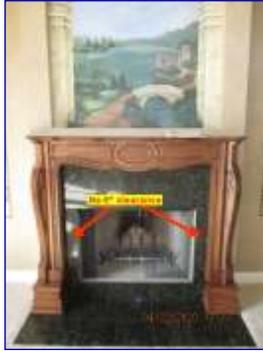
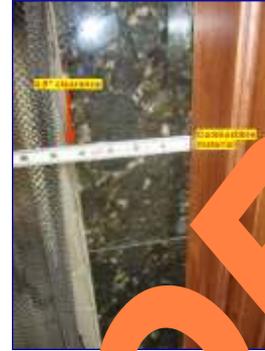
Living Room Fireplace

Living Room Fireplace: This fireplace does not currently fit these requirements, have evaluated and repaired by a professional familiar with these requirements, see photo below.

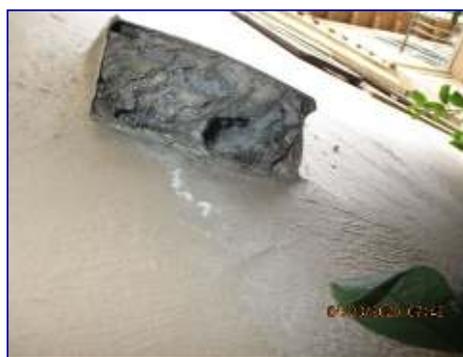
- 1st Floor: The wall dryer vent termination is: too close to HVAC systems, too close to outside air make up, too close to a window or door opening, bent, cracked, dirty, clogged, has no damper, has no weather proof protection, has a screen collecting lint and or is damaged in such a way that it does not perform as it was originally intended. The wall termination point is in general need of repair/cleaning by a HVAC contractor or a contractor that is familiar with all phases of dryer venting. The wall vent must be equivalent to a 4- inch wall termination in regard to resistance to airflow and back-flow prevention and should require little or no maintenance to prevent clogging. More info: <http://www.asnireporter.org/HomeInspection/Articles/The-Facts-About-Clothes-Dryer-Exhaust-Systems/161>

Clogged termination

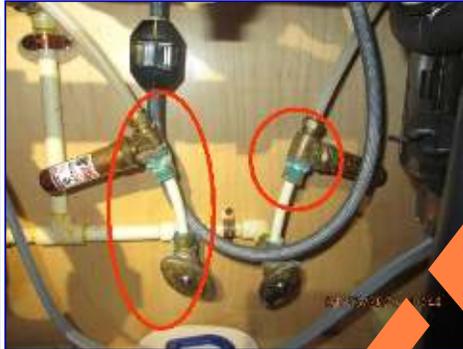
• Deferred cost: lavatory stop valves were observed to have excessive amounts of corrosion or are considered at the end of their useful life. Monitor these conditions closely failure of these valves can cause significant water damage to the interior of the home. We recommend replacement

Corrosion at fittings

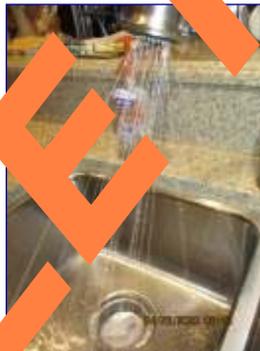
• Hand Spray has an irregular spray. Check aerator for debris and or spray head for lime/calcium buildup. Cleaning with vinegar before other repairs.

Hand Spray and Spray needs cleaning -spray

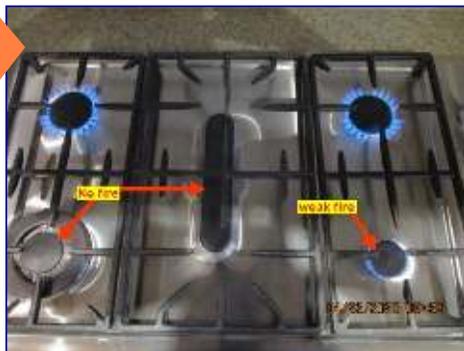
- Propane or Natural gas cook top noted.
- Using normal operating controls, one or more burners would not fire or have a weak/irregular flame, see photo below.

One or more burners will not start

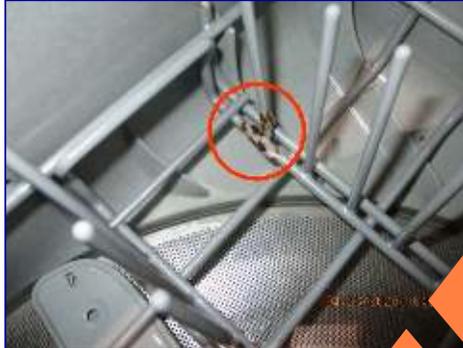
- This includes both dishwashers.
- Dishwasher racks and or silver ware baskets are damaged, rusted, broken and or are damaged, repair/replace as needed.

Rusted rack

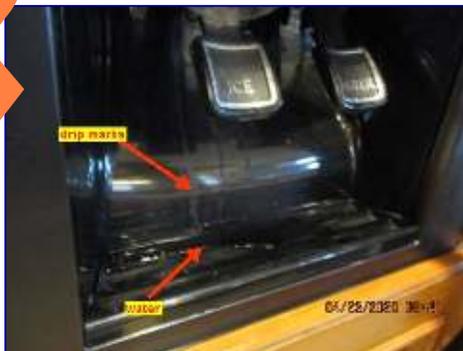
- One or more of the door functions (lights or dispensers) would not operate, is leaking/holding water. Cause for these conditions can be many, have featured inspected and repaired.
- DISCLOSURE: The ice maker appears to be in operation, making ice shaped like the ice maker but several bags of ice were observed inside the refrigerator. This can sometimes be an indication that the ice maker is not working.

Monitor for leaking --drip marks

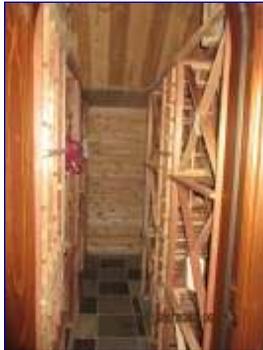
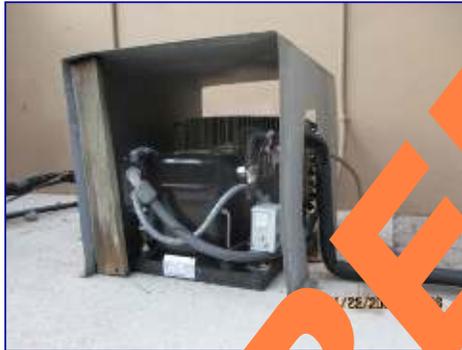
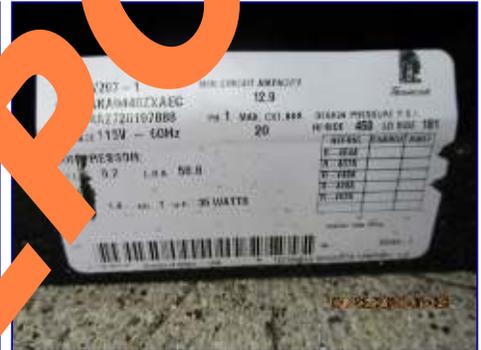
- Wine Cooler
- DISCLOSURE: Proper insulation and construction of wine cooler is paramount. We cannot comment on how the wine cooler was constructed. Improper insulation and construction practices can result in a high microbial like growth.
- Wine cooler temperature: An ideal temperature for wine storage is 55°F to 57°F with 60% relative humidity. The temperature inside the cooler is 79°F. Have a licensed refrigeration contractor evaluate the cooling system for the wine cooler.
